KEEPING LONG-SPAN ROOFING WEATHERTIGHT

By Kenneth J. Guffey, PE

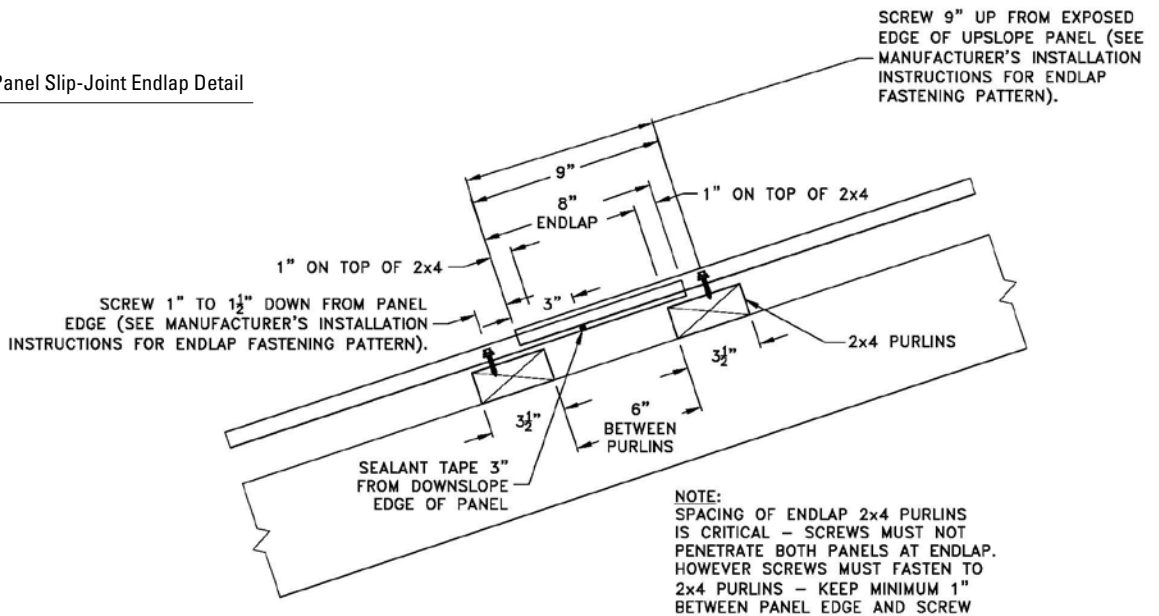
Figure 1. Roof Panel Slip-Joint Endlap Detail

Keeping in mind that panel endlap issues are often caused by a combination of different loads/forces, solutions must consider all these potential forces and not just panel expansion and contraction. For example, areas of a roof system can be strengthened such that movement is relocated to areas better able to handle this movement (i.e. beefing up panel endlap fastening patterns). In other cases, movement is simply too great and must be reduced through a stronger and stiffer frame design. In yet other situations, particularly very long eave to ridge distances, the roof panels must *not* be connected in any way to any adjacent roof panel. This "slip joint" approach, as illustrated in **Figure 1**, is becoming more common because it is very effective in solving the endlap weathertightness issue. However, careful consideration must be given to the structural implications of "un-connecting" roof panels from each other, particularly due to the fact that many post-frame structures
